The Restoration and Conservation of inlaid marble tomb slabs in St John's Co-Cathedral

Tomie McCarthy

HND in Tour Guiding
January, 2023

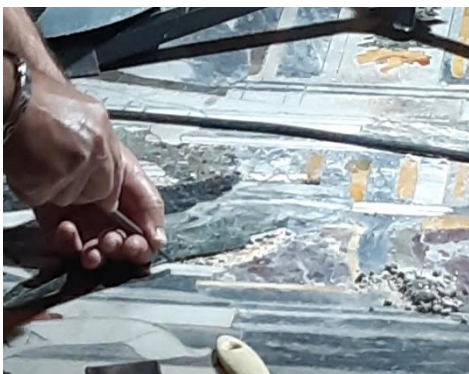
Figure 1

'Figure 1 - Section of the tomb tablet of Fra Felice De Lando – St John's Co Cathedral, Valletta - Tomie McCarthy – 12.05.2022' – [Image on the left show removing old materials]

Mr. Bartolo starts by examining carefully the state of the marble floor, as well as old restoration parts which had been done before, and sometimes missing pieces or holes in the marble are replaced with matching marble. In the past, if a *marmista* couldn't find any matching marble, cement or wax (Colofonia) glues would be used to fill in the gaps. This was the old-style method of restoring missing pieces of inlay. However, these methods caused another type of damage to the marble, because of the acid they contain which wears down the marble itself. As a consequence, if damages appear, the old parts need to be removed carefully (see Fig 1 and Fig 2) and cleaned with specific solvents. They are then replaced with matching marble. This is also done to conceal gaps between marbles. He adjusts the shape and size and replaces the marble on the spot (see Fig 3). He explained that if there was no matching marble, temporarily polyester resins were used, which would be mixed with a pigment to match the marble's colour.

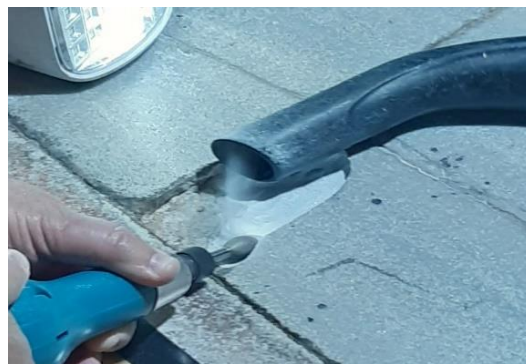
Figure 2

'Figure 2 - Section of the entrance to Oratory – St John's Co Cathedral, Valletta - Tomie McCarthy – 29.04.2022' – [Image on the right shows preparing to place a new marble piece]

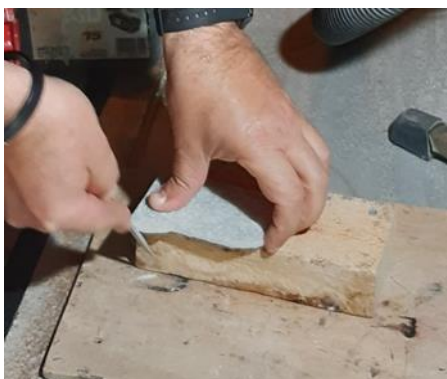
Figure 3 - Section of the entrance to Oratory – St John's Co Cathedral, Valletta - Tomie McCarthy – 29.04.2022' – [Image on the left shows adjustment the new marble piece]

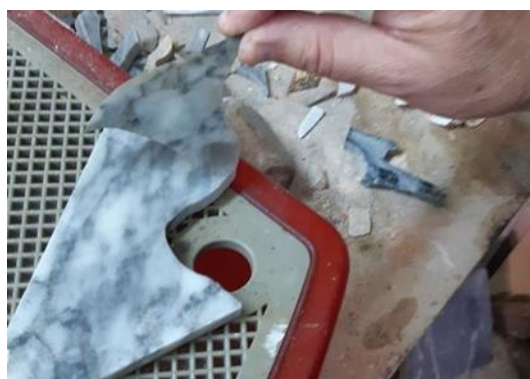
Figure 4 - -- The workshop at St John's Co Cathedral, Valletta - Tomie McCarthy – 14.05.2022' – [Image on the right shows distresses new marbles]

Although most of the marbles used in the tomb slabs in St John's come from Italy, some marbles are imported from France, Spain, Belgium, and Africa. Even more rare marbles were imported during the Knight periods from around the world. Mr. Bartolo currently has kept at least 35-40 different types of marbles at St John's workshop, but sometimes it is not easy to find exactly the same marble. Although some of the marbles may no longer be in use, Mr. Bartolo researches and sometimes finds a matching marble from dealers at the international marble fair. Not only does he find matching marble for missing pieces, but sometimes he distresses the new marble to make it look old (Fig 4). With his constant dedication to work at St John's, observers can hardly tell which part of the marble pieces have been replaced.

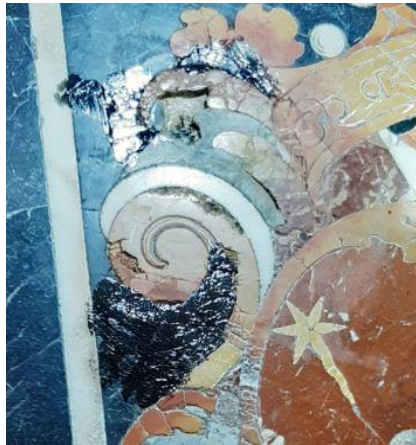
Figure 5 - Section of the tomb tablet of Antoine De Pety De Vitre – St John's Co Cathedral, Valletta - Tomie McCarthy – 21.06.2022' [Image on the left shows the consolidation process of Black marble (Nero de Belgio)]

Marble tomb slabs contain inscriptions which describe the deceased knight's name, sometimes his ancestry, place of origin, military achievement, and virtues. The publication of 'The Church of St John in Valletta' by Hannibal Scicluna gives us remarkable information on the tomb slabs. The Order often commissioned known foreign marble artisans from Sicily, and Florentine sculptors to enhance the decoration of their churches. The average cost of each tomb slab was between 100 and 200 scudi (Debono, 1999). Some tomb slabs were designed by Malta's leading Baroque artist Francesco Vincenzo Zahra (1710-1763) and Italian architect Romano Fortunato Carapecchia (1666–1738). The consolidation process for marble floors is also very common for historic floors as the literature review shows. The timing of consolidation is a very important and efficient way of preserving floors. Cracks are observed in various areas of the inlaid marble floor in St John's. When the mother slab and the inlaid marble lose perfect adhesion, the marble can crack when pressure is applied to specific areas. The type of marble and the natural vein in the material itself can develop damage as time passes (Cassar, 2011). In the cracks, consolidations are carried out with Polyester resin with a mixture of pigment in accordance with the colours of the originals and bonding of the fractured parts and detachments.

This preservation process is very important to keep the original marble. Mr. Bartolo tries to save the original marble pieces that are fixed on the tomb slab for as long as possible. Mr. Bartolo also explained, "The priority is to leave the original marble even though it is small pieces, so that will give marble a longer life for the next generation to see and admire. That is the beauty of restoration", This shows, his

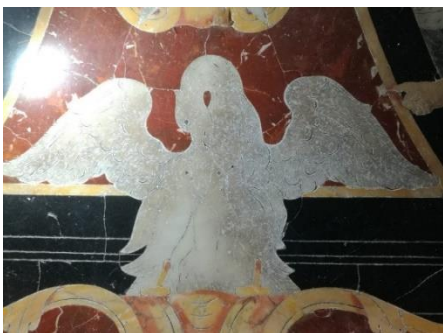
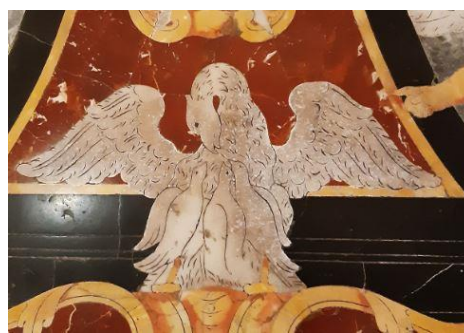
'Figure 6 - Section of the tomb tablet of Fra Antonio Scudero before restoration – St John's Co Cathedral, Valletta - Tomie McCarthy – 21.06.2022' – [Images show examples of a section of a tomb tablet before and after restoration]

Leaving tomb slabs in their original state means inscriptions and designs fade because of a lot of grit that is brought inside by visitors and scratches on tomb slabs that appear over time. Mr. Bartolo recovers the lettering freehand before the entire inscription or design fades. Skilled techniques are required for inscribing. These inscriptions and motifs are more visible after the restoration. If the entire design were completely eroded, Mr Bartolo will not be able to recover inscriptions or designs. even though he could imagine what it looked like before. He respects the original artists. Some parts of tomb slabs are completely faded designs which might be too late to trace back because of no clear documentation left.

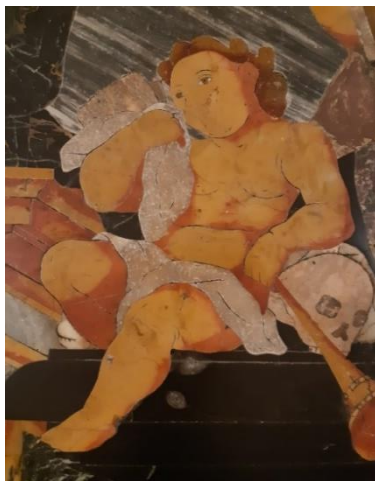
Figure 7

'Figure 7 - Section of the tomb tablet of Melchior Alpheran de Bussan – St John's Co Cathedral, Valletta - Tomie McCarthy – 12.07.2022' – [Image on the left shows examples of shadow using the flame it changes colour and reddens as can be seen]

One of the most interesting techniques in marble inlay is creating the illusion of depth sometimes also referred to as three-dimensional design. Giallo di Siena is a yellow marble originally from Siena. A characteristic of this type of marble is that when it is put in contact with the flame it changes colour and reddens as can be seen (Fig 7). During the Baroque era, putti and other allegorical figures were mostly furnished in this way, which can be observed in many tomb slabs at St John's as well as other churches around the island. [Munro, 2010] Mr. Bartolo also makes shadows using a burner after the replacement of a new piece as needed. Even with the same marble, the density of the colour is used to create a three-dimensional effect. It is also a very important skill to grasp the characteristics of marble in order to restore it to the original design as much as possible. Knowing the veins of marble is one of the most important skills for *marmista*, and as the picture shows, the use of mixed coloured marble to create a 3-dimensional design.

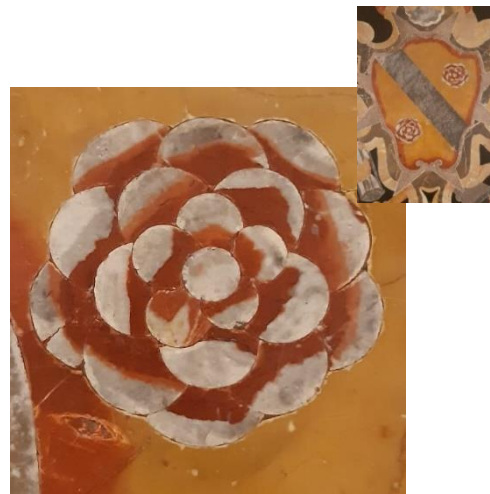
'Figure 8 – Section of the tomb tablet of the tomb tablet of Fra Francesco San Martino De Ramondetto – St John's Co Cathedral, Valletta - Tomie McCarthy – 12.07.2022' [Image on the right show examples of 3 dimensional stone work. The Figure 8 shows that marbles were selected as if it looks like a natural petal, using the character and vein of Rosso de Franza's two colours, red and grey.]

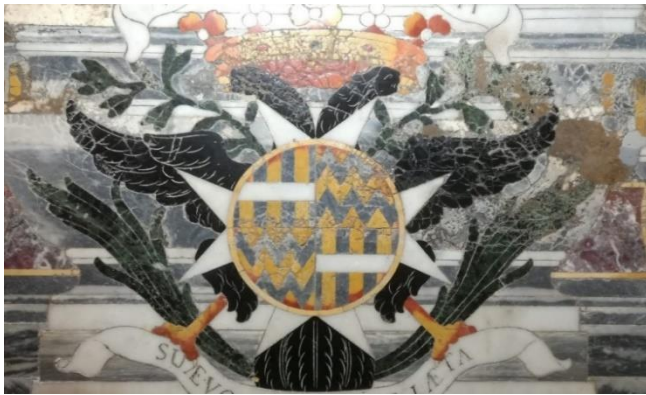
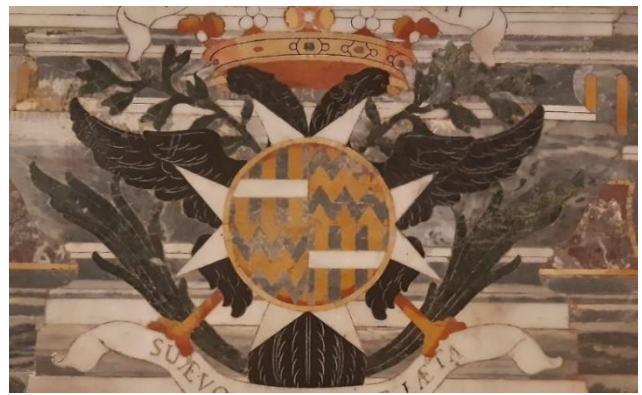
Figure 9 Before the restoration

Figure 10 After the restoration

'Figure 9 & 10 – Section of the tomb tablet of Fra Felice De Lando – St John's Co Cathedral, Valletta - Tomie McCarthy – 07.05.2022 & 09.07.2022' – [Above images show an example of a section of the tomb tablet before and after restoration used with almost all the techniques introduced in the research.]

to clean inlaid marble floors in St John's, because each marble has a different character. Some of them are very hard, and some of them are very fragile. For this reason, no chemicals were used to clean the inlaid marble floor. The surface is cleaned using organic solvents and applying polishing with the machine will be carried out every few years.
